Pentney Quarry, Proposed Extension

Date: 03 November 2017
File Ref: MA/P17 - 1305
Subject: Access Strategy

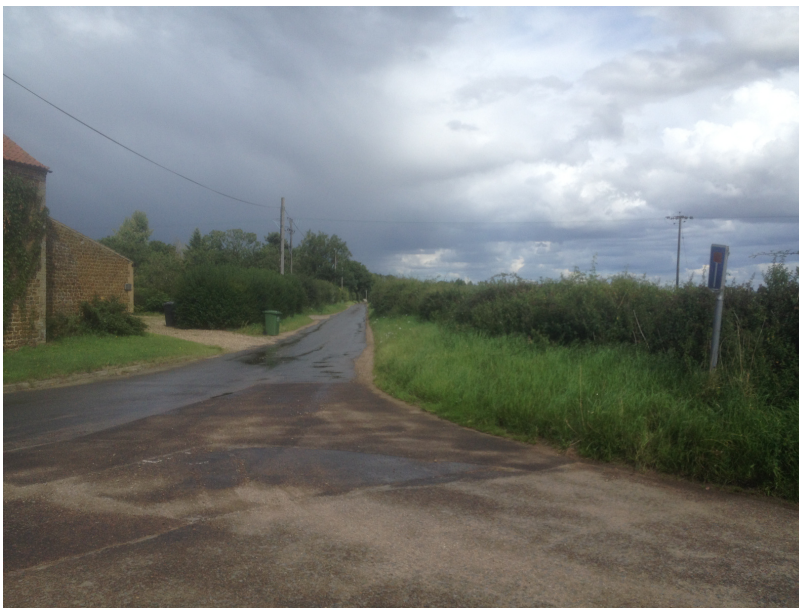
Photo 1: Access Road/Common Road-Abbey Road junction looking East

- 2.3 The existing HGV route along Common Road and connecting with the A47 to the North is illustrated on drawing 1305/03/101.
- 2.4 Common Road itself follows a meandering alignment and varies in width from between 3.5m at its narrowest (to the South) to approximately 6.0m at it widest. The narrowest section of Common Road is between the aforementioned junction and the ford to the North of the access serving the Pentney Lakes leisure development, covering a distance of approximately 500m over which length a series of informal passing places have developed on both sides of the carriageway through scrubbing out of the verge.

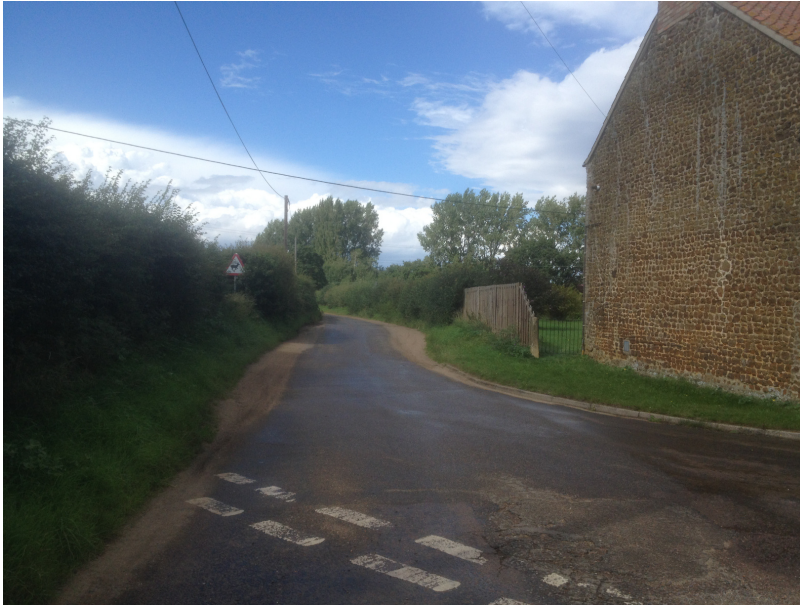
Photo 2: Access Road/Common Road-Abbey Road junction looking North

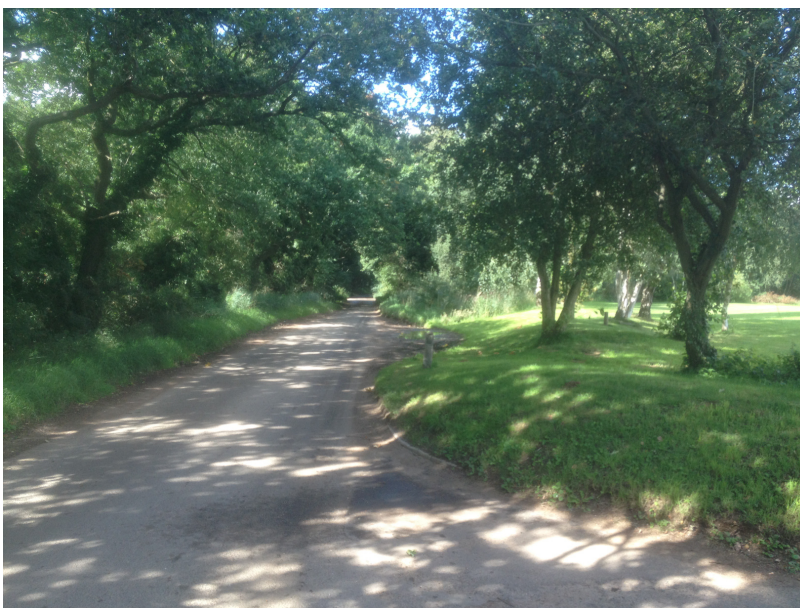
Photo 3: Example passing place on Common Road (North of the Pentney Lake access)

- 2.5 It is reasonable to assert that a proportion of this historic verge erosion has been attributable to HGV movements to/from the quarry at Pentney. In conjunction with the proposed development it is recommended that these passing places should be formalised by means of full depth road construction and signing (as required). While it may not be possible to fully achieve NCC Highway's indicative specification for passing places (e.g. overall carriageway width of 5.5m over a length of 20m with 5m tapers each end) formalising the existing, naturally evolved passing areas will still offer a significant improvement to this route for the passage of two-way traffic.
- 2.6 Drawing 1305/03/101 shows (indicatively) the locations for the proposed passing place improvements along the aforementioned section of Common Road.

- 2.7 It should be noted that the passing place improvements shown on drawing 1305/03/101 are subject to being achievable within the existing highway boundary in conjunction with the implementation of the proposed development. Following NCC Highways’s acceptance in principle of the improvements outlined on drawing 1305/03/101, further work would be undertaken including formal highway boundary search and preliminary design work based on a topographic survey of the relevant section of Common Road.

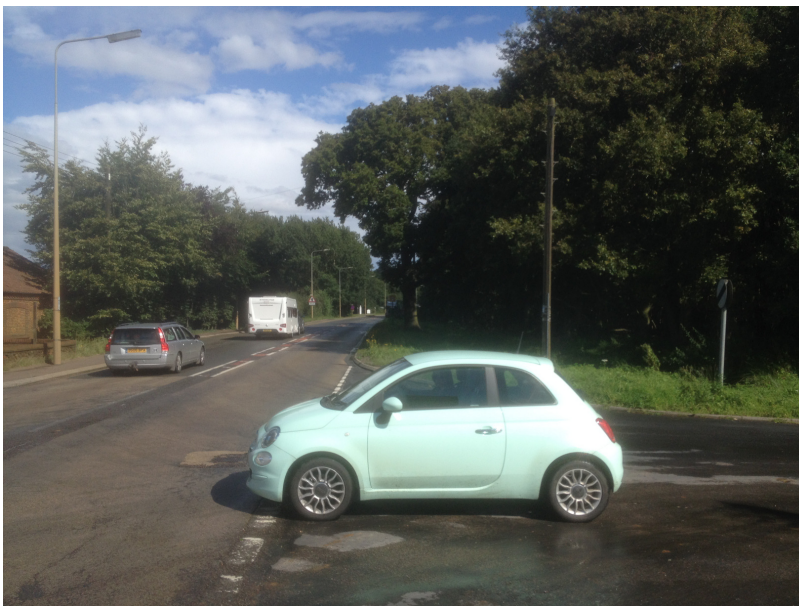
Photo 4: Common Road/A47 junction (looking East)

- 2.11 Common Road connects with the A47 via a simple T-junction with Station Road connecting to the North side of the carriageway to form a crossroads arrangement. Visibility from Common Road onto the A47 is extensive to the West, however, to the East vegetation partially hinders the line of sight (Photo 4). It is recommended that Highways England review the levels of visibility potentially available at this junction within the highway boundary and arrange for verge maintenance, as appropriate.

- 2.12 The accident data obtained from NCC Highways shows a series of accidents having occurred at the Common Road/A47/Station Road crossroads over the five year review period. Although it is noted that HGVs were involved in some of these incidents, HGV movements do not appear to have been the actual cause of any accidents at this location. Additionally, there are no incidents shown involving HGVs turning to/from Common Road.

- 2.13 There are extensive road marking and surface treatment measures at this junction, however, these have become faded and were clearly in need of refreshing (as of 18 August 2016). Refreshing of the existing road markings and surface treatment at this junction would likely have a positive effect on highway safety at this location and it is recommended that Highways England review this situation and take action, accordingly.

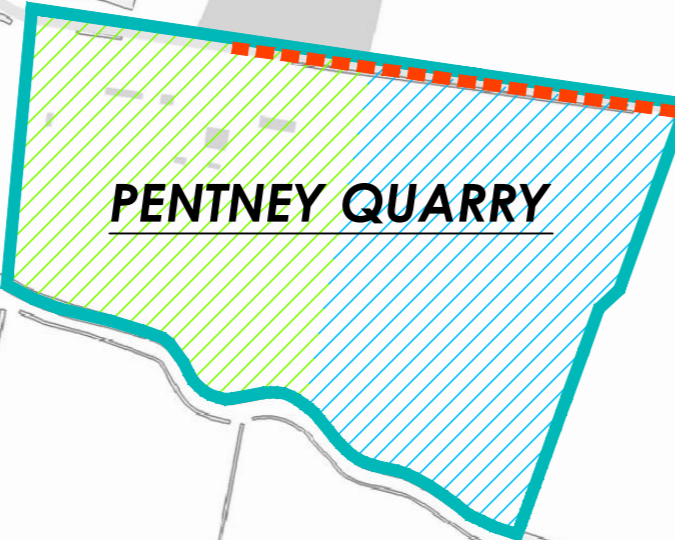
DRAWING TITLE ACCESS PLAN WITH PROPOSED IMPROVEMENTS	SCALE(S) NTS	DESIGNED MDA	
CLIENT MIDDLETON AGGREGATES LIMITED	JOB No 1305	CHECKED MDA	
	DRAWING No 03/101	APPROVED MDA

Proposed signing enhancements on the A47(T) approaches to the Common Road/ Station Road junction

- - - PROPOSED HGV ROUTE TO/FROM PENTNEY QUARRY (LINKING TO A47(T))
- PROPOSED PASSING PLACE IMPROVEMENTS
- / / / CURRENT OPERATIONAL AREA
- / / / PROPOSED EXTENSION OF OPERATIONS

- 2.14 In conjunction with the proposed development and in respect of the existing safety record of this junction, Middleton Aggregates Ltd would be prepared to fund the upgrading of the existing junction warning signs to feature yellow backing boards. These, in conjunction with the aforementioned visibility and road marking/surface treatment measures (by others) should serve to make the junction more conspicuous to general traffic on the A47, which in turn should see a reduction in overall accident activity at this location. The proposed signing improvements being offered by the Developer are shown indicatively drawing 1305/03/101.
